## Senior Project: Masonry Core Testing

By: Enrico Alvaro and Onessa Anastasio

Date: June 20, 2017

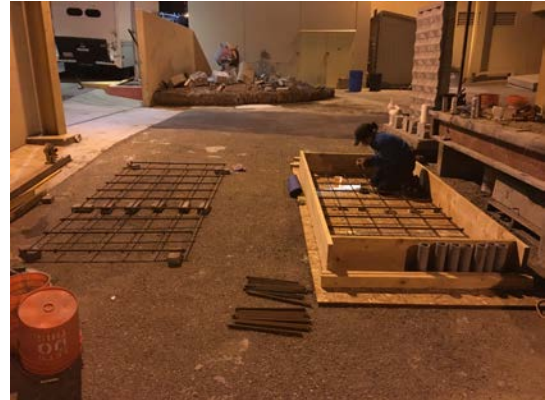
**Figure 1: Tying rebar cages into the slab formwork**

Prior to construction, the Failure Wall needed a new testing slab in High Bay. The existing testing slab would be used for the control wall. This way, we can construct and test both walls simultaneously. The dimensions of the new slab was 9 feet by 4.5 feet and 1 foot thick. It was reinforced with no. 4 longitudinal rebar at 11" o.c and no. 6 latitudinal rebar at 10" o.c, top and bottom. 1.5-inch anchor bolts at 3 feet o.c was considered in the form work. These anchor bolts would be bolted to the High Bay Lab floor to prevent uplift. Reinforcing for the openings were also considered. Hooks were designed for mobility of the foundation to be lifted with the crane. See Appendix 1 for plans and sections of the slab.

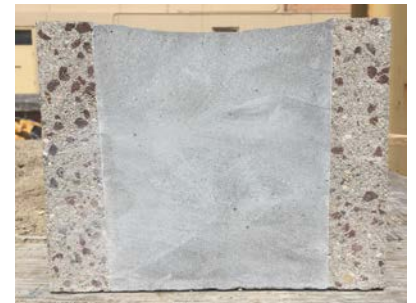
**Figure 8: Paper Towel**

From the first tests, the acrylic paint gave the best result such that one face shell fell off. This was tested by being able to pull the face shell by hand strength. No other face shells fell off the other specimens; however, the Thompson's Water Seal and the paper towel showed visible separation between the grout and the CMU. The candle wax was ineffective. With these results, we decided to do a second pass with 2 layers of paper towel and Thompson's Water Seal on acrylic paint. Two layers of paper towel would give a thicker separation and Thompson's Water Seal would give an extra water sealable coat on the acrylic paint.

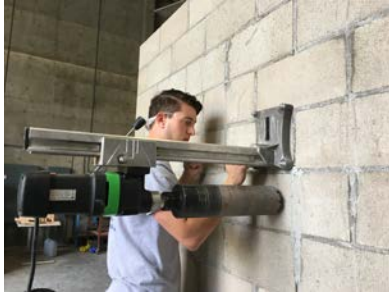
**Figure 15: Mounted coring drill**

Core testing will validate the efficiency of the delaminating agent and ensures a failure so the experiment may proceed as designed. Coring was performed per CBC 2105A.4. The holes were re-grouted with the same grouting mix during construction. Using a coring rig lent by Kurt Siggard, the drill was mounted with Hilti expansion anchors at the same locations in both walls. This was to maintain control of any differences between the two walls – aside from the grout to CMU bond.

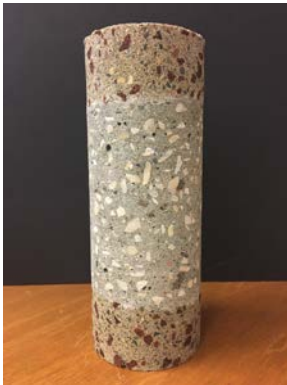
**Figure 17: Controlled wall core specimen**

Figure 17 shows the intact core specimen from the controlled wall. Figure 18 shows a visible cohesion of the grout into the CMU block.

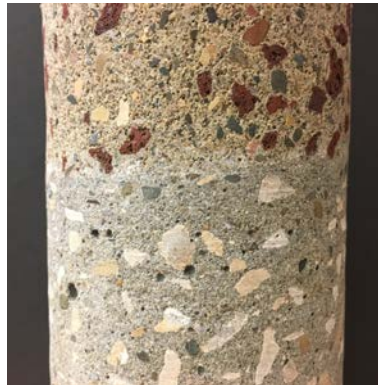
**Figure 18: Grout to CMU bond**

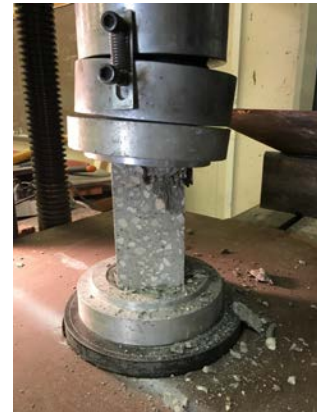
**Figure 23: Omitted sample**

The average grout strength for both the failure samples and the control samples was roughly 3400 psi. One failure sample was omitted. During testing, the top plate shifted applying load at an angle causing spalling. Therefore, the entire sample was not properly engaged by the compression device.

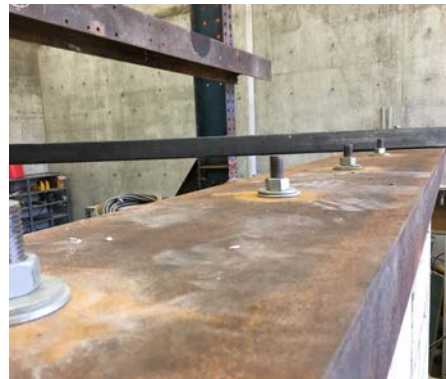
**Figure 25: Channel engaging top anchor bolt**

Before we can proceed to testing, we created a pinned connection at the top of the wall. The anchor bolts embedded at the top of the wall were engaged to produce a connection similar to a wall fully braced by a diaphragm. We used a C12x20.7 faced down to hug the top of the wall and engage the bolts. 3-inch square tubes were bolted at each end of the channel and clamped to the wide-flange column approximately 6-feet away from the wall. The tubes were purposely placed at each end to reduce any possible torsion effects from testing. To save material and time, the bracing was constructed to fit both walls.

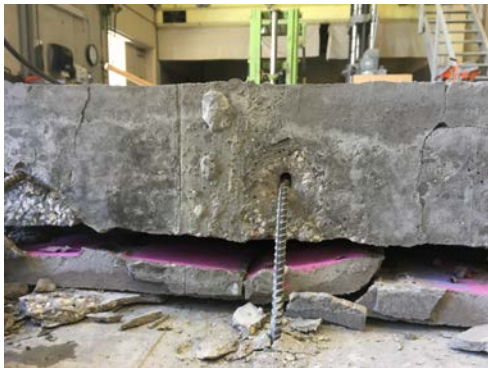
**Figure 32: Failure wall base**

The foundation that the failure wall was built on was not completely roughened at the base of the wall. During the demolition process of the failure wall, it was apparent the foundation was too smooth for stronger cohesion. There could have been a stronger bond at the base like that of the other foundation. The other foundation had a cross hatch on the slab to allow the mortar and grout to interlock. Figure 29C shows the remaining two block layers still attached to the slab. Figure 31 shows the base of the failure wall completely detached from the slab. The smooth surface of the grout and mortar can be observed.

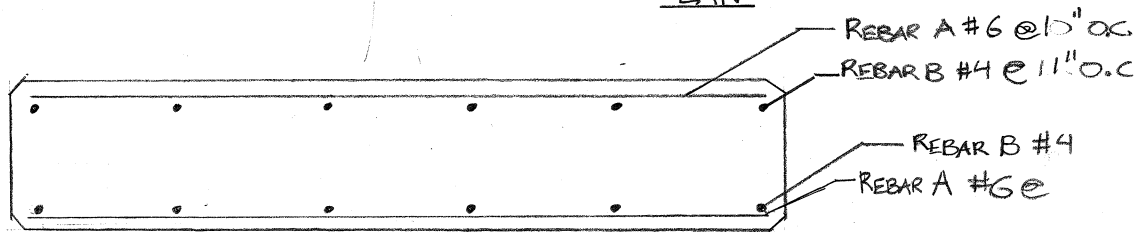
PLAN

THICKNESS = 12"

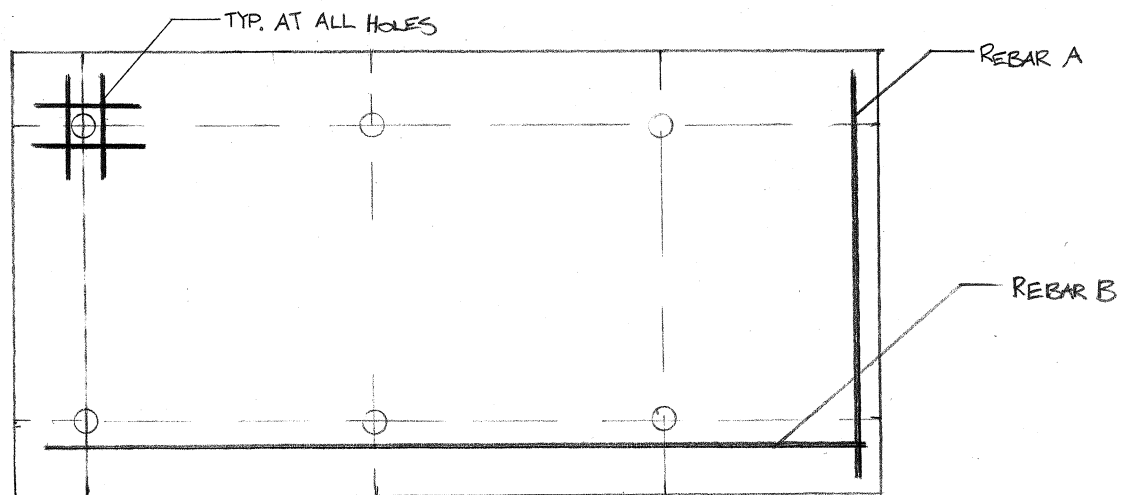
SECTION A-A

- REBAR A/B TYP. TOP AND BOTTOM
